Manhole Inspection Summary

Manhole # S59U__004MH

Insp Date: **11/25/08 9:29 AM**

Location Address: **4700 Holabird Ave.**

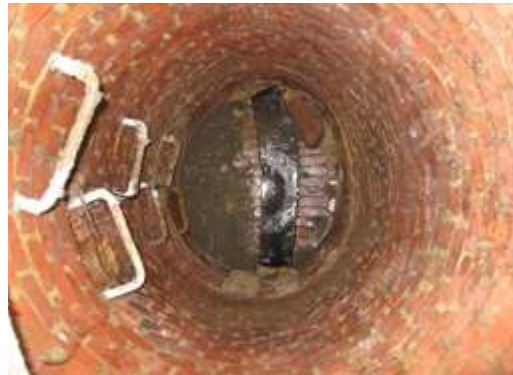
Top View

Comments **MANHOLE LOCATED AT OLD SIDEWALK. NOW COVERED IN OLD RUBBLE AND ROCKS. BEHIND A FEW CONCRETE JERSEY BARRIERS USED FOR CONSTRUCTION.**
